WATER TREATMENT PLANT REHABILITATION

Denver-Area Water Treatment Facility Uses Structure Guard® – Water to Rehabilitate Leaking and Corroded Flume and Weir

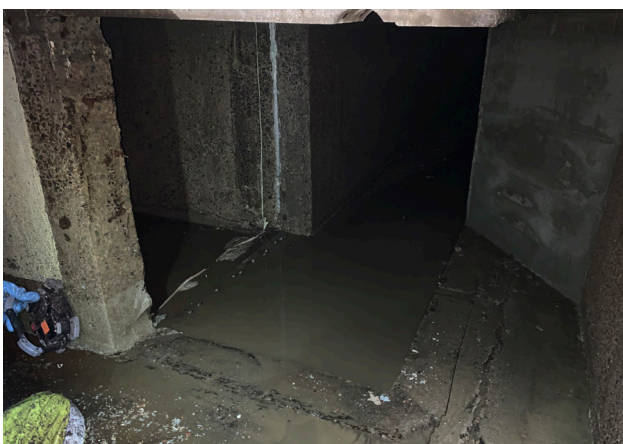
BEFORE: Wastewater Treatment Plant (WWTP) flume entry had begun to leak around the seams.

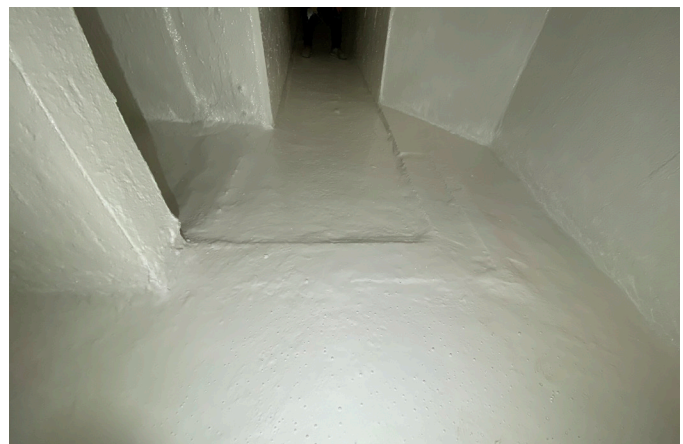
AFTER: WWTP After patching and sealing leaks with Hyperform®, the flume entry way fully rehabilitated with Structure Guard - Water.

- **Step 1: High-pressure cleaning and prep of both the flume and weir**
- **Step 2: Fill voids and patch cracks with rapid-set Quadex Hyperform®**
- **Step 3: Spray-apply 80mils of Structure Guard® - Water**
- **Step 4: Visual inspection, holiday testing and adhesion testing (Pull Test) at 780psi**

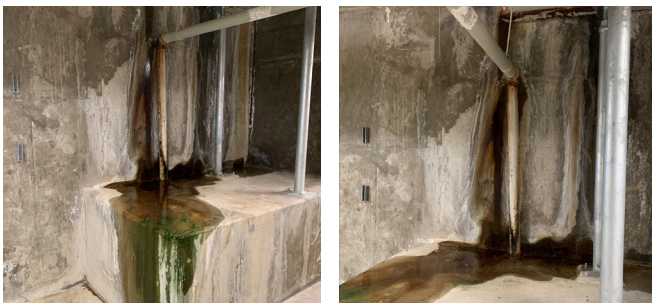
BEFORE: Water had begun leaking through multiple seams and puddling on heavily used walkways, creating a safety issue. Additionally, they identified a heavily corroded overflow weir used to ensure a uniform flow rate and avoid short-circuiting.

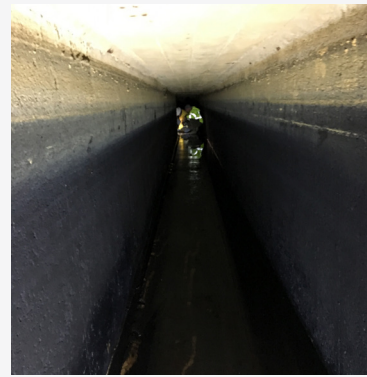
BEFORE: 100LF section of a 4' x 4' boxed-shaped potable water flume was leaking and creating safety issues along the walkway.

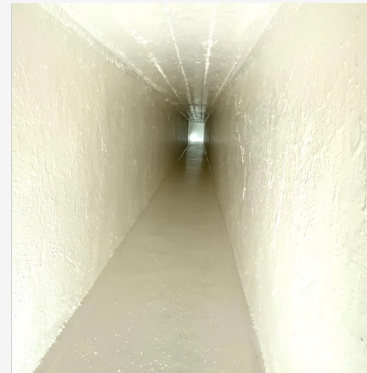
AFTER: After the voids and cracks were sealed with Hyperform®, the flume was coated with 80 mils of Structure Guard - Water for long term protection.

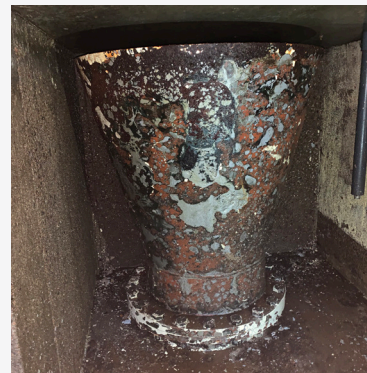
BEFORE: A weir was so corroded it was no longer functioning.

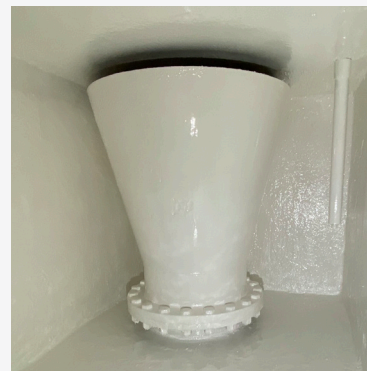
AFTER: Application of Structure Guard - Water at 80mils thickness.
