Structure Guard® Fully Restores Critical Water Reclamation Facility Pipe in 19 Days, without Operational Interruption

PROVEN EPOXY MATERIAL DELIVERS LONG-LASTING DURABILITY IN HIGH H₂S ENVIRONMENTS

South Valley Water Reclamation Facility

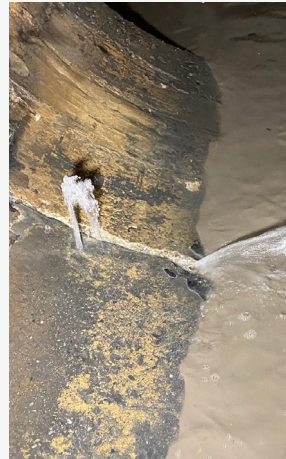
I & I Guard-PRF was used to stop several high-flow points of infiltration.

Prior to application, a bypass was installed to isolate the pipe and remove standing water. Cardinal Coatings then injected I & I Guard-PRF into pre-drilled holes at all points of infiltration. This fast-acting grout can stop leaks in a matter of seconds. This was followed by a 5,000 psi pressure wash to remove loose sediment and achieve a CSP profile of 4-6.

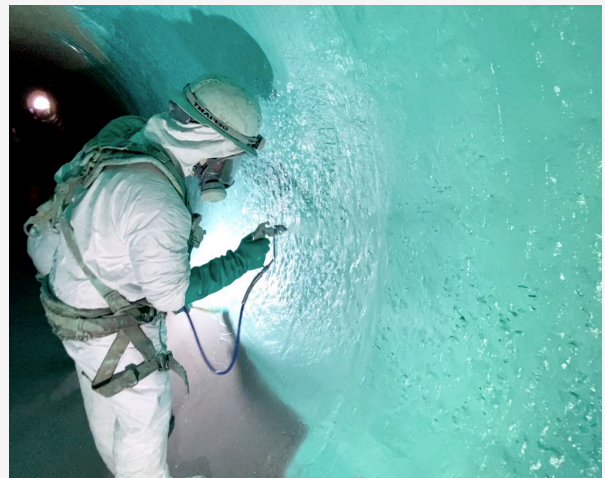
Structure Guard is spray applied using a dual component spray application system to achieve a consistent thickness of 250 mils throughout the pipe.

The project was completed in just 19 days, without interrupting the facility's operations. Structure Guard® was applied at 250 mils to protect the RCP pipe from H₂S attack for many years to come.
