GeoKrete®

Geopolymer Mortar

For raw, storm and wastewater infrastructure rehabilitation.
Manholes | Tunnels | Culverts | Pipe | Wet Wells | And More...

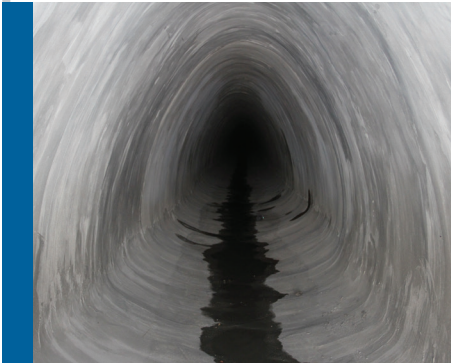
39M DEEP MANHOLE/106M EGG-SHAPED CULVERT REHABILITATION

A 39m deep brick manhole constructed in 1912, along with a 106m of 1980mm x 1675mm brick culvert built in 1915, had reached the end of their useful lives and were in a state of imminent failure.

- Shear depth of the manhole presented challenges. A specially equipped man lift was used to lower crew into manhole.
- 15 large baffles originally built into the manhole structure had to be removed and the voids repaired.
- The culvert outfall was at the base of a steep slope with 60° incline; made access difficult.

The Quadex Lining System® featuring GeoKrete geopolymer. Installation thickness optimized applying varying thicknesses ranging from 25mm to 76mm to provide a fully structural renewal and eliminate I&I.

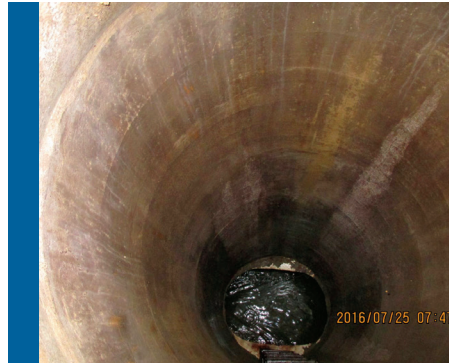
10-YEAR FOLLOW-UP ON GEOKRETE LINED MANHOLES

15 manholes located in Northern Wisconsin, previously coated with a polyurea, were already failing after one year. Extensive flaking and peeling was present indicating a complete failure was imminent.

Quadex® GeoKrete geopolymer was specified to correct the problem and applied with the spinMASTER® system to ensure a consistent lining from top to bottom. A trowel was then used to smooth-out the finish. Since GeoKrete has a quick cure time, the manholes did not have to be taken out of service.

In 2016 the manholes were re-inspected. There were no signs of failure or degradation.

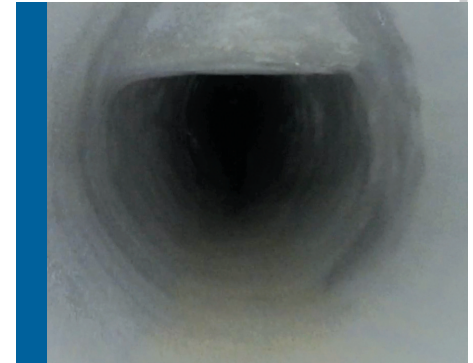
BRICK SEWER REHABILITATION IN FRONT OF BOSTON GENERAL HOSPITAL

A section of an old sewer was odd shaped, contained obstructions and could not be CIPP lined. Since it was located near the hospital entrance a trenchless solution was the only option.

The Quadex Lining System, featuring GeoKrete, was used to reline and structurally restore 492m of 1370mm x 914mm brick sewer. It was spray-applied to the odd-shaped sewer and was able to cover the obstructions as well.

GeoKrete Geopolymer liner is still in the same condition as the day it was installed.
